Manhole Inspection Summary

Manhole # S27S1_001MH

Inspection ☐ Is Incomplete Rating: **4) Poor**

Location Address: **801 Marmenco Ct.**

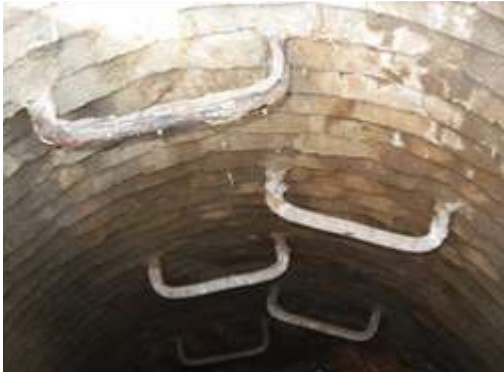
Steps

Count: **5** Missing: **0** ☒ **Corroded**

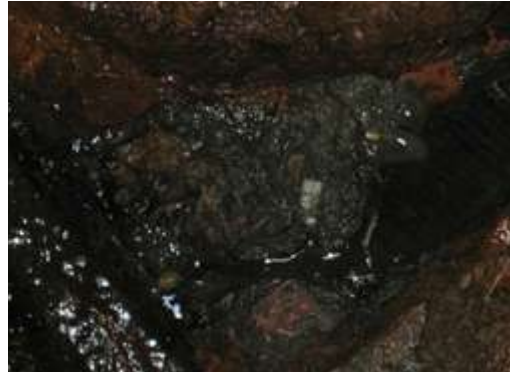
Defect 2

Waste in channel

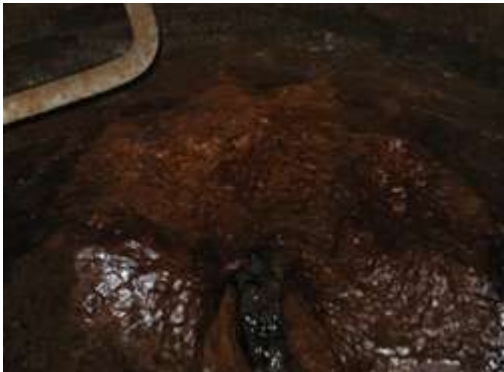
Defect 1

Infiltration: ☐ None ☐ Joint ☐ Cracks ☐ Mortar ☐ Roots ☒ **Wall**

Wall infiltration

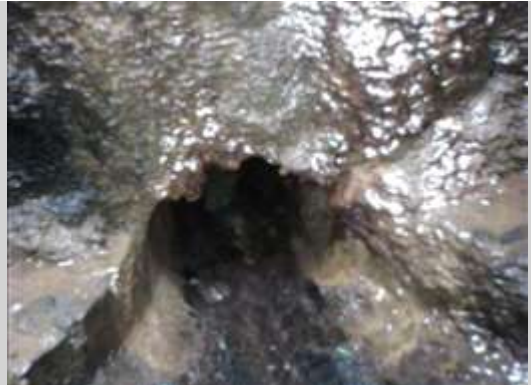
12 O'Clock Outflow

8 in. Circular Gravity Sewer
Pipe Out @ 12 O'Clock

Pipe Height: **8.4** (in.) Rod and Bar (Angled)
Pipe Material: **Clay** ☐ Pipe Lined
Invert Depth: **10.28** (ft.) Flow Characteristics: **Fast**
Deposits: ☒ None ☐ Mud ☐ Sludge ☐ Debris ☐ Grease
Silt Depth: (in.) Deposits Extent:
Infiltration: **None** Pipe Seal Cond: **Sound**

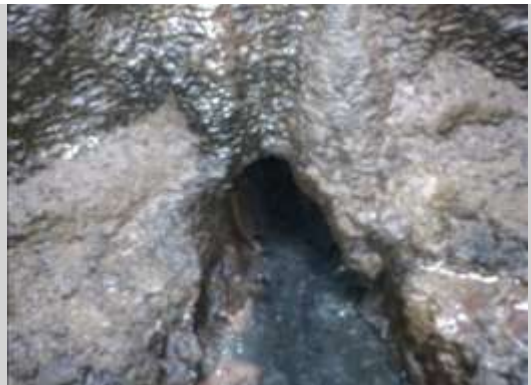
3 O'Clock Inflow

6 in. Circular Gravity Sewer
Pipe In @ 3 O'Clock

Pipe Height: **7.2** (in.) Rod and Bar (Angled)
Pipe Material: **Clay** ☐ Pipe Lined
Invert Depth: **9.96** (ft.) Flow Characteristics: **None**
Deposits: ☐ None ☐ Mud ☒ **Sludge** ☐ Debris ☐ Grease
Silt Depth: **2** (in.) Deposits Extent: **Medium**
Infiltration: **None** Pipe Seal Cond: **Unknown**

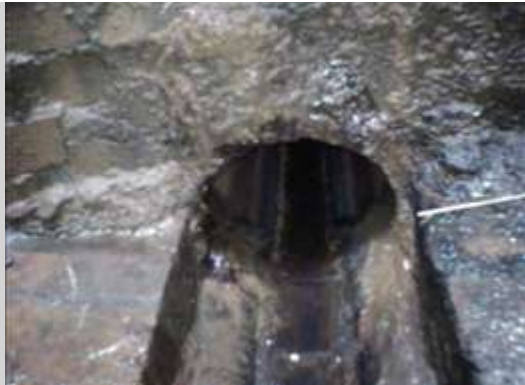
6 O'Clock Inflow

8 in. Circular Gravity Sewer

Pipe In @ 6 O'Clock

Pipe Height: **8.4** (in.) Rod and Bar (Angled)

Invert Depth: **9.98** (ft.) Flow Characteristics: **Fast**

Deposits: ☒ None ☐ Mud ☐ Sludge ☐ Debris ☐ Grease

Infiltration: **None** Pipe Seal Cond: **Sound**

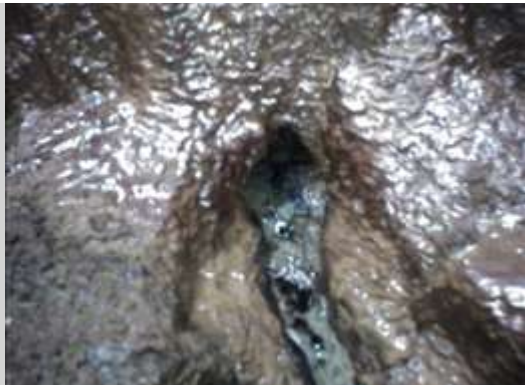
9 O'Clock Inflow

6 in. Circular Gravity Sewer

Pipe In @ 9 O'Clock

Pipe Height: **7.2** (in.) Rod and Bar (Angled)

Invert Depth: **9.96** (ft.) Flow Characteristics: **Fast**

Deposits: ☒ None ☐ Mud ☐ Sludge ☐ Debris ☐ Grease

Infiltration: **None** Pipe Seal Cond: **Sound**

Connects To: **Dead End**
